Manhole Inspection Summary

Manhole # S25EE1007MH

Insp Date: **1/24/07 9:37 AM**

Location Address: **3970 EDGEHILL AVE**

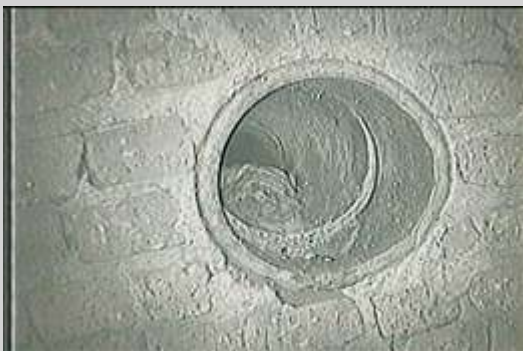
8 in. Circular Gravity Sewer Pipe In @ 3 O'Clock

Infiltration: **Evidence** Pipe Seal Cond: **Cracked**

Drop: **Outside** Rod and Bar
Angled: **Yes** Reading: **8.64** (ft.)
Inv Depth: **9.64** (ft.)

Drop Condition: **Partly Clogged**

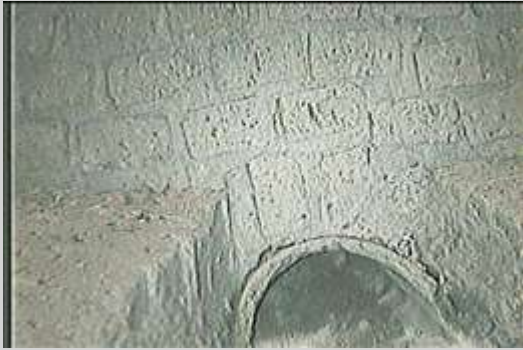
8 in. Circular Gravity Sewer

Infiltration: **None** Pipe Seal Cond: **Unknown**
